Contract #: 04-0120F4Cty: SF/ALA Rte: 80 PM: 13.2/13.9File #: 78.28**WELDING INSPECTION REPORT****Resident Engineer:** Casey, William**Address:** 333 Burma Road**City:** Oakland, CA 94607**Report No:** WIR-030042**Date Inspected:** 16-Sep-2013**Project Name:** SAS Superstructure**OSM Arrival Time:** 1500**Prime Contractor:** American Bridge/Fluor Enterprises, a JV**OSM Departure Time:** 1700**Contractor:** Steward Machine Co.**Location:** Birmingham, AL**CWI Name:** Fred Hudson**CWI Present:** Yes No**Inspected CWI report:** Yes No N/A**Rod Oven in Use:** Yes No N/A**Electrode to specification:** Yes No N/A**Weld Procedures Followed:** Yes No N/A**Qualified Welders:** Yes No N/A**Verified Joint Fit-up:** Yes No N/A**Approved Drawings:** Yes No N/A**Approved WPS:** Yes No N/A**Delayed / Cancelled:** Yes No N/A**Bridge No:** 34-0006**Component:** E2 Shear Key Anchorages**Summary of Items Observed:**

Quality Assurance Inspector (QAI) Andrew Webster traveled from Corpus Christi, TX to Birmingham, AL to perform Quality Assurance at Steward Machine. This QAI was present on the date and times noted above in order to observe the fabrication and Quality Control (QC) functions performed by

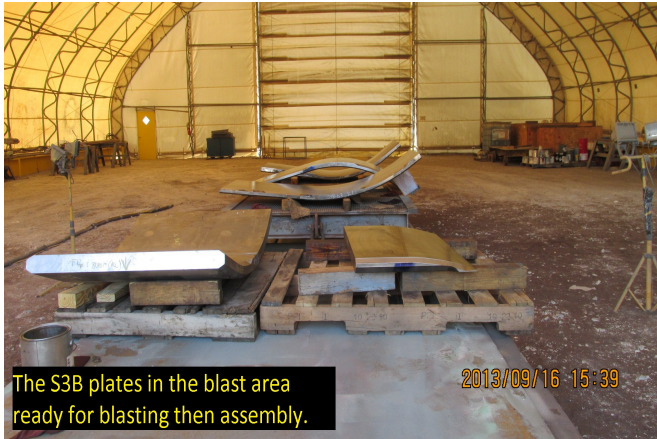
S3B-b3. Formed, stressed relieved and partially machined.  
S3B-c3. Formed, stressed relieved and partially machined.  
S3B-d3. Formed, stressed relieved and partially machined.  
S3B-f3. Formed, stressed relieved and partially machined.  
S3B-g3. Formed, stressed relieved and partially machined.  
S3B-h3. Formed, stressed relieved and partially machined.

The S3B plates in the blast area ready for blasting then assembly.

This QAI was informed by the paint area supervisor that the plates for the S3B assembly would be blasted around 4am and then they would be assembled for welding.

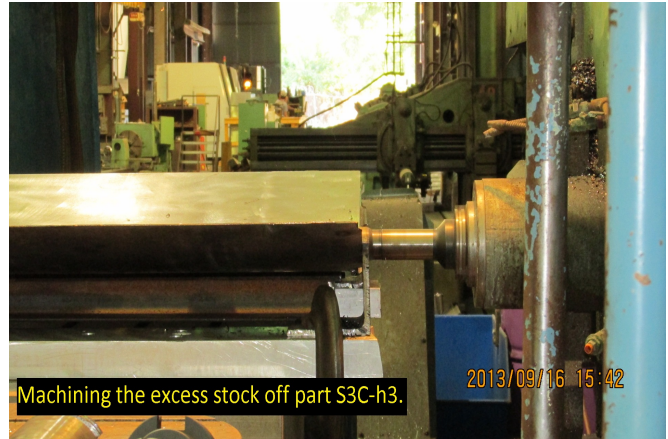
CNC Machine #245 milling plate S3C-h3. (Milling excess stock off)

Machining the excess stock off part S3C-h3.
